# Evaluation of Dowel Bar Inserter Practices in PCC Pavements with Magnetic Tomography Technology

Report MPMC-04

Final Report  
26-1121-4027-001

December 2016

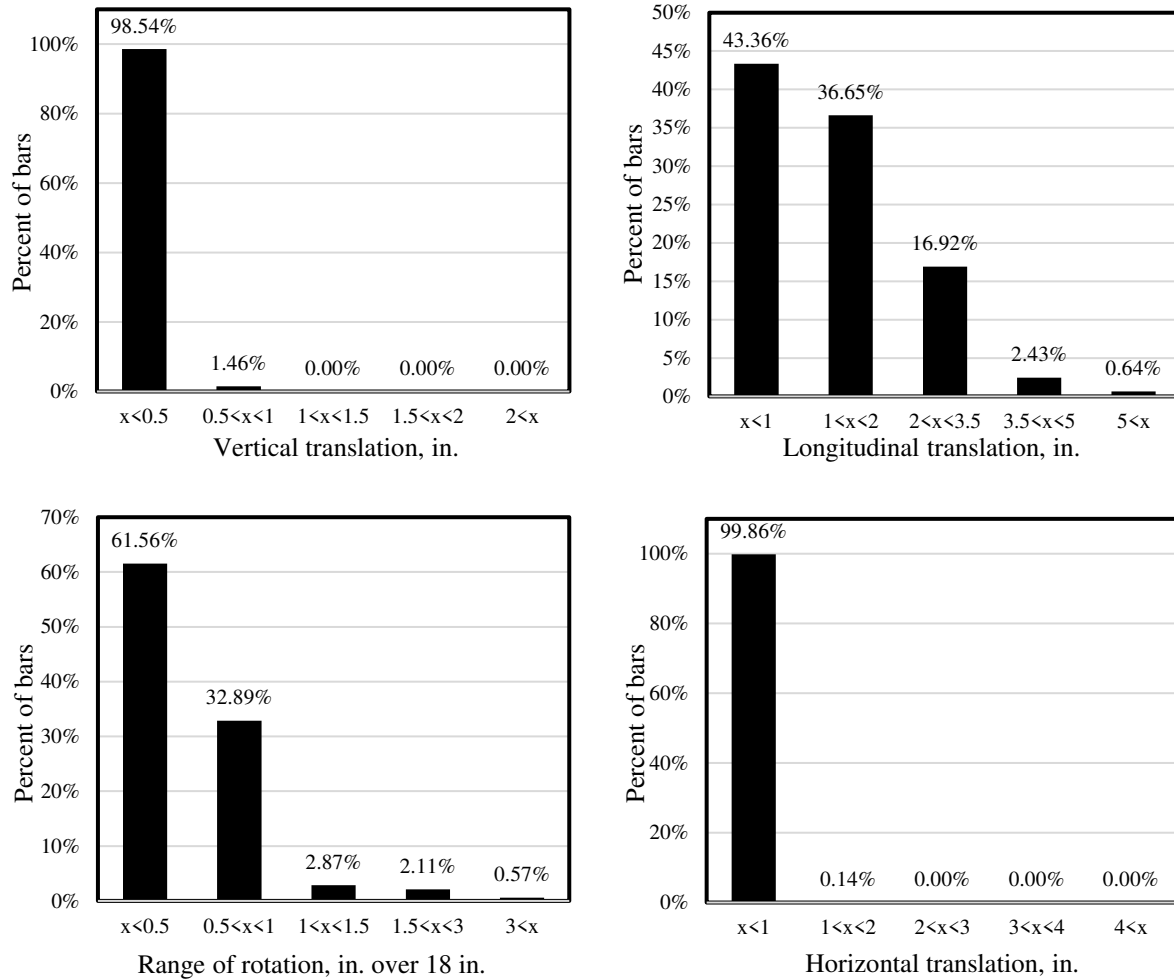
**Figure 3.1** Dowel misalignment values of Hooper project

Figure 3.1 shows the dowel positions for the 110 joints scanned in the US 275 “Hooper” project, which was completed in 2009. It can be seen that vertical and horizontal translation of the dowels is not a concern, while high longitudinal translation and rotation of the dowels is present. Approximately 20% of the dowels fall outside acceptance criteria for longitudinal translation (2.0-2.1 inches), and 1 joint has to be rejected based on ACPA and FHWA rejection criteria due to average longitudinal translation of 5.1 inches. However, it should be noted that no distress was observed during the field performance measurement of this joint.

As for dowel rotation, 6% of the dowels fall outside acceptance criteria and 3% of the bars should be rejected based on ACPA and FHWA criteria. Many of the dowels with high values of rotation were in the same joint that should be rejected due to longitudinal translation. Three missing dowels were also identified on separate joints in the Hooper project. All of the missing dowels lay in the vehicle wheel-path and thus the load distribution among dowels is expected to be adversely affected.

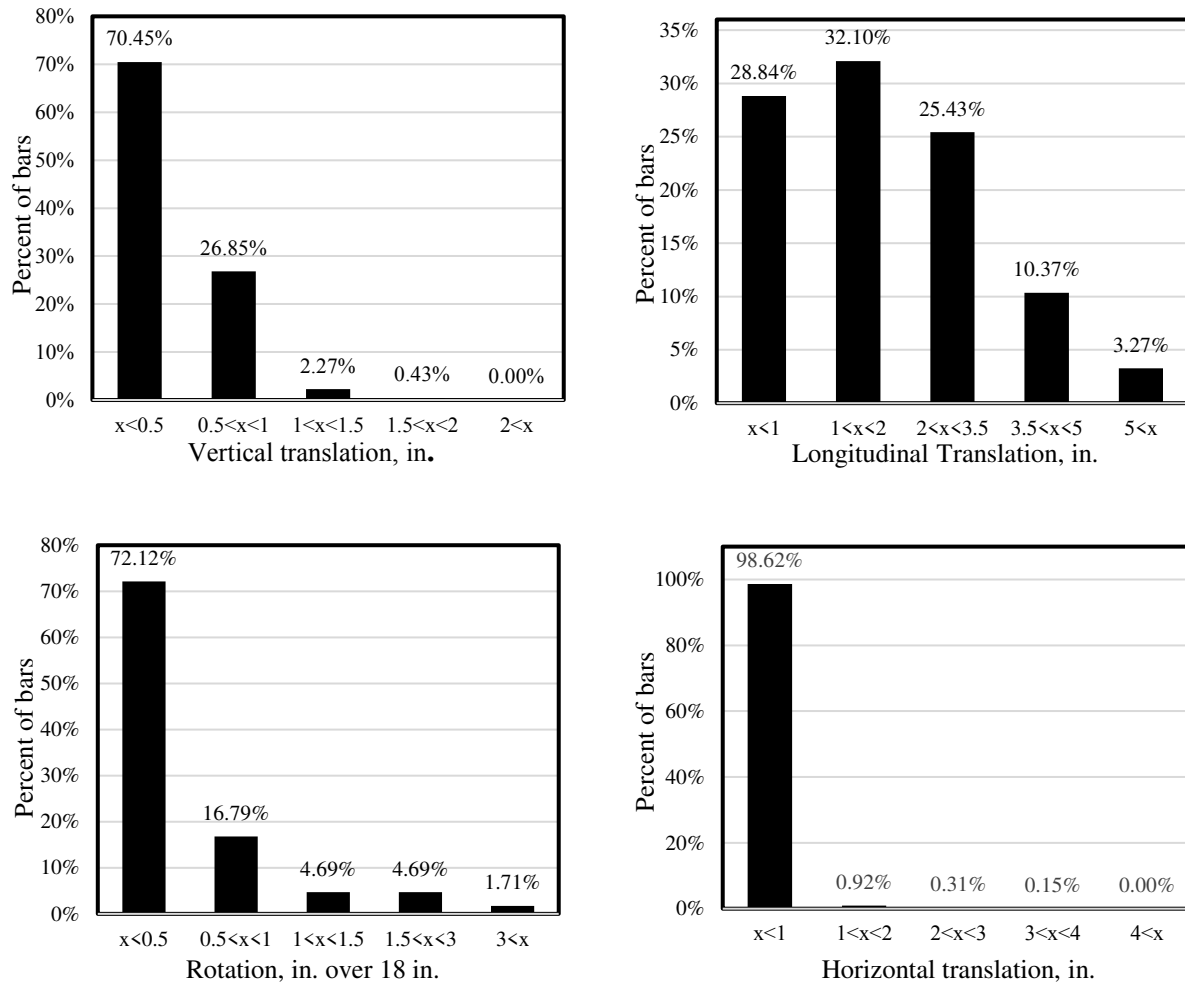
**Figure 3.2** Dowel misalignment values of Kimball project

The dowel misalignment values of the 55 joints in SR 71 “Kimball” project can be seen in figure 3.2. Compared to the previous project, higher longitudinal and vertical translation of the dowels can be seen. Only 60% of the dowels showed acceptable longitudinal translation values, and 3 joints should be rejected based on ACPA and FHWA criteria. However, 97% of dowels presented acceptable vertical translations, and the other 3% still have sufficient concrete cover based on all criteria. Regarding rotational misalignment, four joints will be rejected based on the criteria of all agencies, two of which also had excessive longitudinal translations.

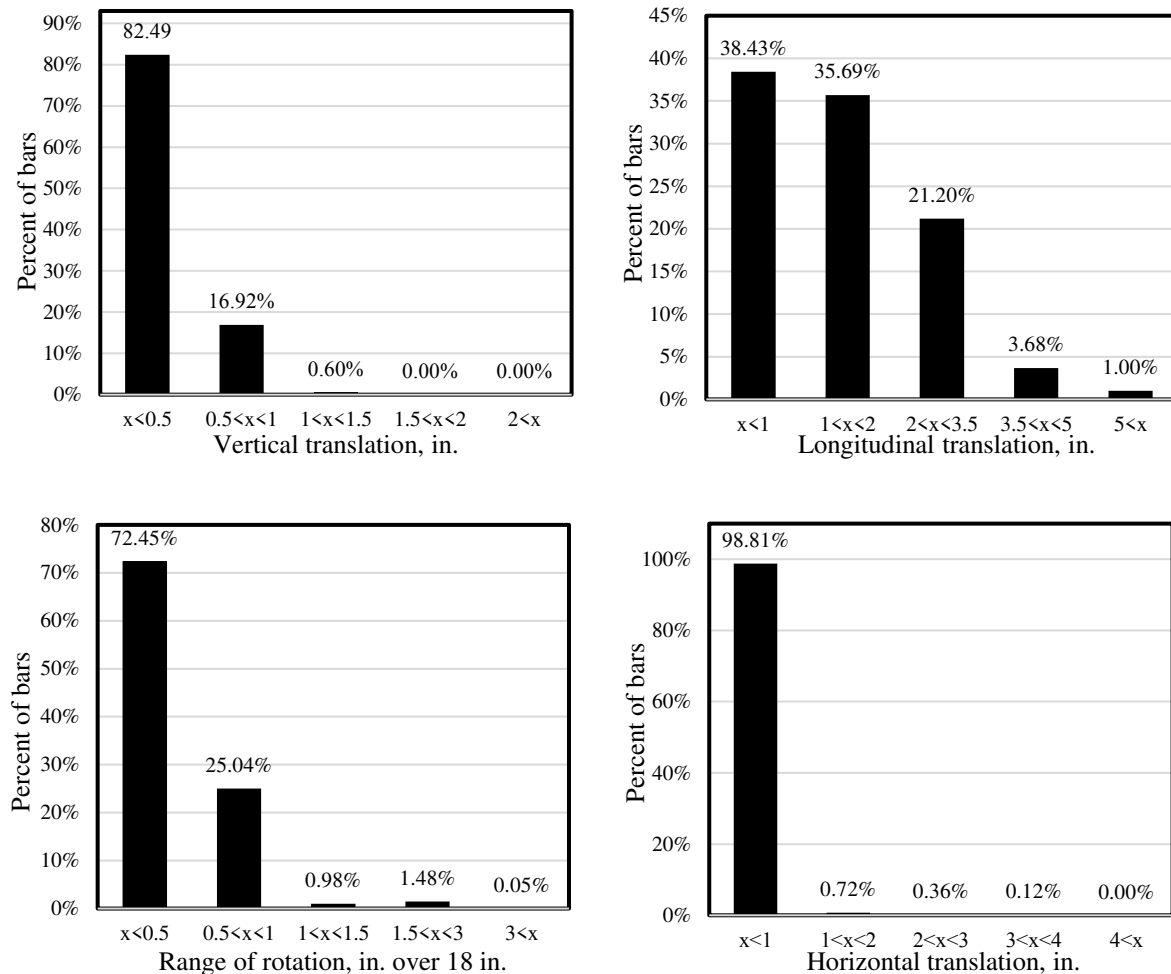
**Figure 3.3** Dowel misalignment values of Roscoe project

The dowel misalignment values of the I-80 project “Roscoe”, and the US 275 project “Norfolk” can be seen in figures 3.3 and 3.4. The number of joints scanned for the projects were 155 and 175, respectively. The east and west directions of Norfolk were completed in 2005 and 2009 respectively, while Roscoe was completed in 2012. Similar to previous projects, both Norfolk and Roscoe showed acceptable vertical and horizontal translations. The dowels in Roscoe project have higher longitudinal translation with 35% of dowels falling outside acceptance criteria of national agencies , and 3 joints that have to be rejected, while Norfolk has 12% of dowels outside

acceptance criteria and 3 joints that need corrective action. It can be noted that field investigation showed zero to 1 mm. faulting for those three joints.

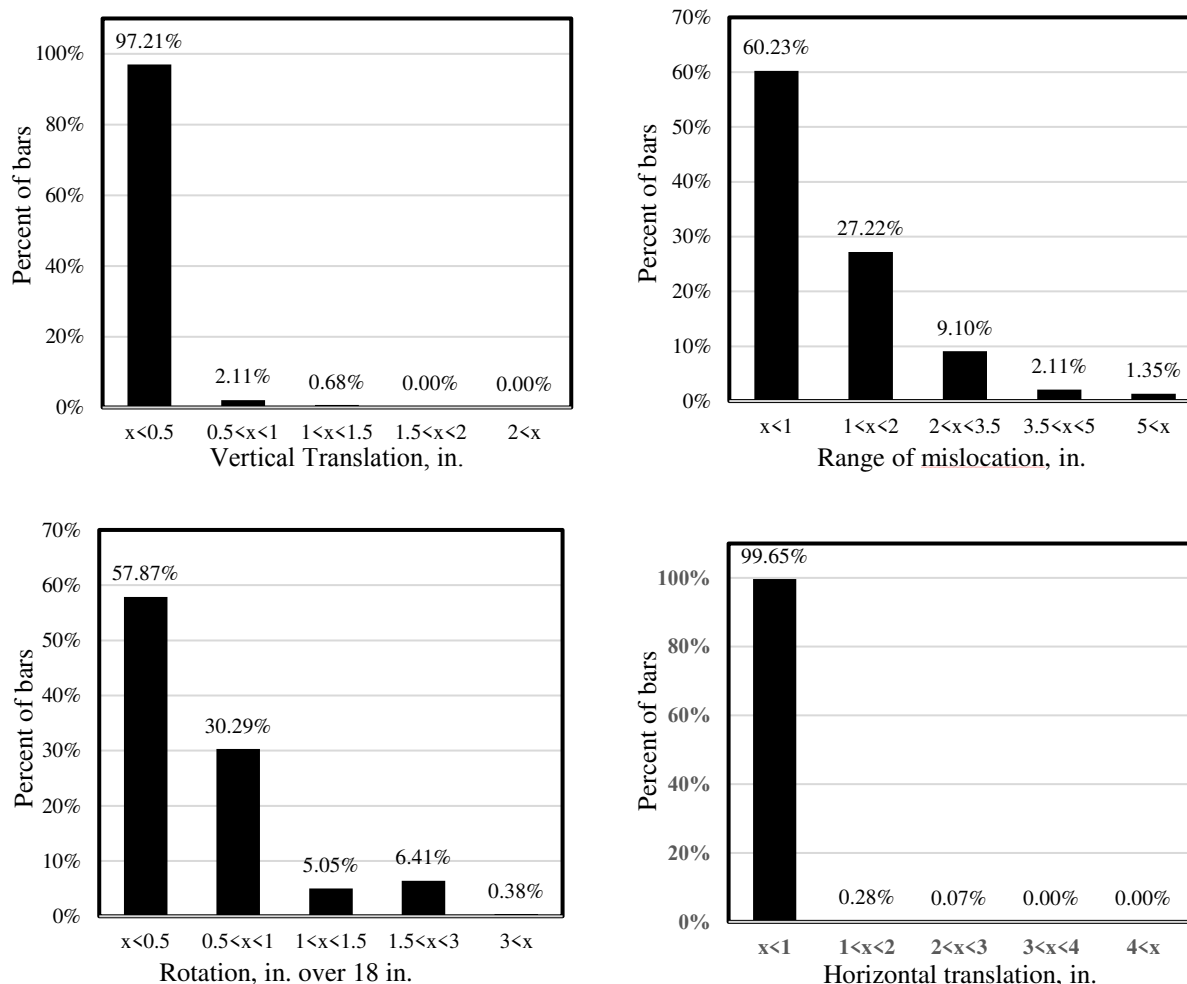
**Figure 3.4** Dowel misalignment for Norfolk project

The Norfolk project has higher rotational misalignment compared to Roscoe, with 12% outside acceptable tolerances compared to less than 3% for Roscoe. Seven percent of Norfolk joints fall outside the rejection criteria of FHWA and ACPA, compared to less than 2% for Roscoe.

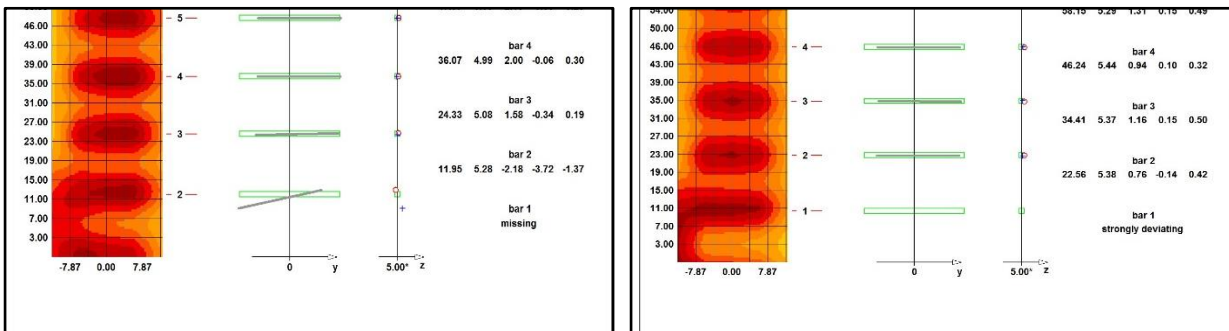
**Figure 3.6** Tie bar interference

Interference from tie bars were observed in approximately 20% of the joints in the Norfolk project. Figure 3.6 shows examples of the interferences in two of the joints. Such joints have been excluded from the data investigation and analysis due to high measurement errors, which make the results unreliable.

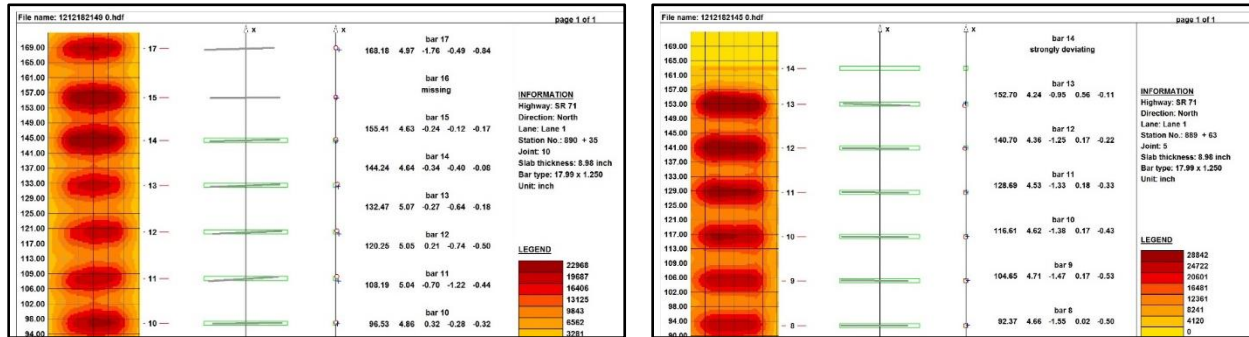
**Figure 3.7** Erroneous dowel identification by MagnoProof software

A few instances of the MagnoProof software mistakenly identifying the dowels as missing or strongly deviating was also encountered during data investigation. Examples of such joints are shown in figure 3.7. Such occurrences, together with the existence of foreign metals that can affect

the results, show that the results provided by the software are not always correct, and manual inspection of individual joint contours is necessary for a reliable quality assurance approach.

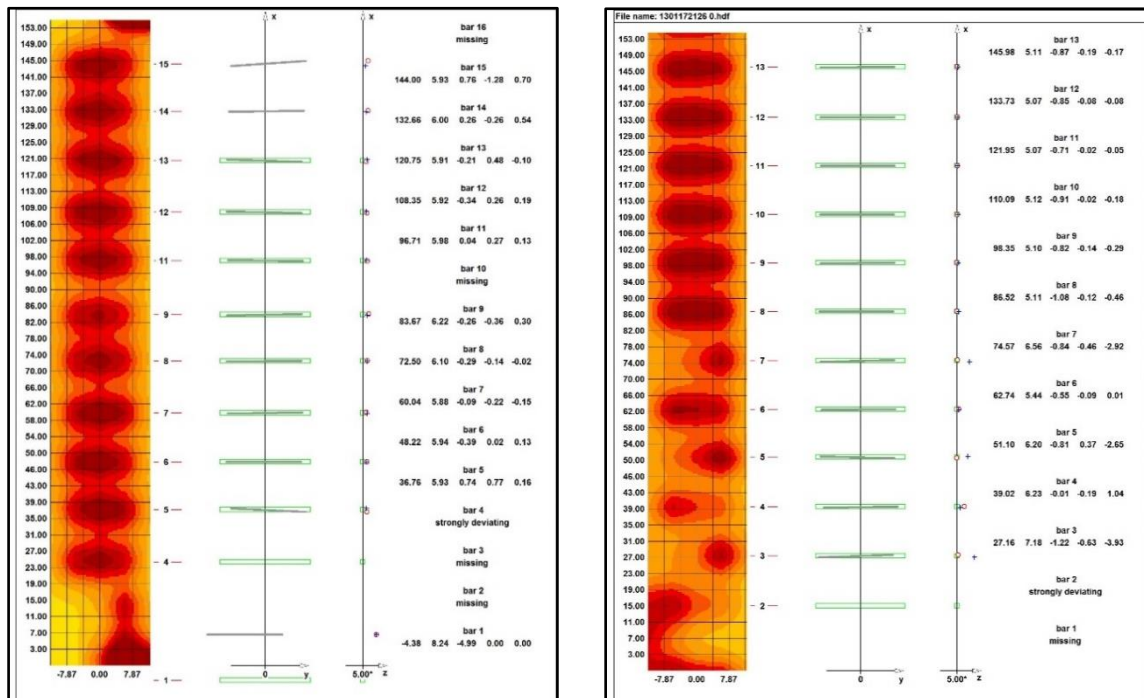
**Figure 4.1** Examples of joints excluded from analysis

Some of the joints in Norfolk project had dowel misalignments that could not be captured by typical misalignment categories, and thus these joints were not included in the data analysis task. Examples of two joints are presented in figure 4.1. From the signal intensity contour, it can be seen that some of the dowels in the joint are completely shifted and have lost their effectiveness. It is worthy to note that the joints in this figure had faulting values of 2 to 3 mm, which were among the highest faulting values observed on the Norfolk project. In spite of that, the

misalignment values reported by the MIT Scan-2 device does not capture the condition of the joint. Therefore, these joints have not been included in the analysis.

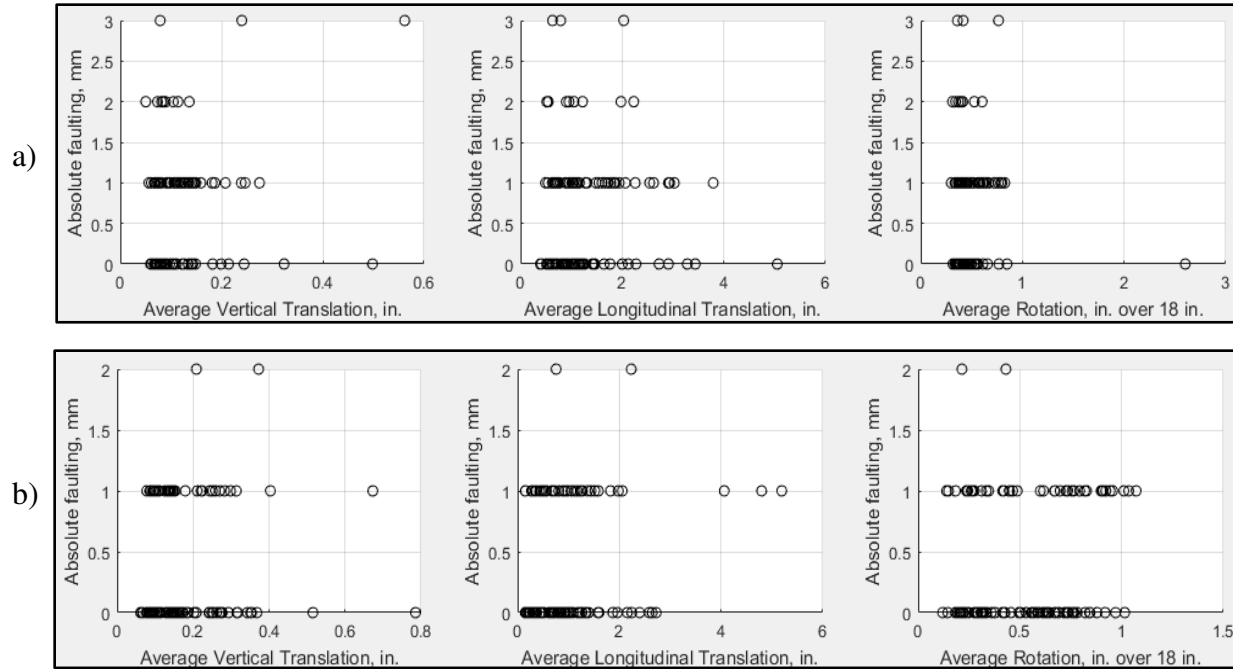
**Figure 4.2** Faulting as a function of average dowel misalignment for (a) Hooper and (b) Norfolk

In order to analyze the effect of longitudinal translation, vertical translation, and dowel rotation on faulting at joints, faulting-misalignment graphs were developed for Hooper and Norfolk projects. Figure 4.2 shows the faulting value of each joint as a function of the average misalignment value of the joint dowels. If there is a relation between faulting and the extent of misalignment observed in the field, a trend is expected in the graphs. However, no such trend is visible, and it can be seen that higher faulting values (>2mm) occur at all ranges of dowel misalignment, which means that the high value of faulting is likely caused by factors other than dowel misalignment.
