research report

Field Demonstration of Magnetic Tomography Technology for Determination of Dowel Bar Position in Concrete Pavement

1. Report No. FHWA/VTRC 06-R40	2. Government Accession No.	3. Recipient's Catalog No.	
4. Title and Subtitle Field Demonstration of Magnetic Tomography Technology for Determination of Dowel Bar Position in Concrete Pavement		5. Report Date June 2006

June 2006
VTRC 06-R40

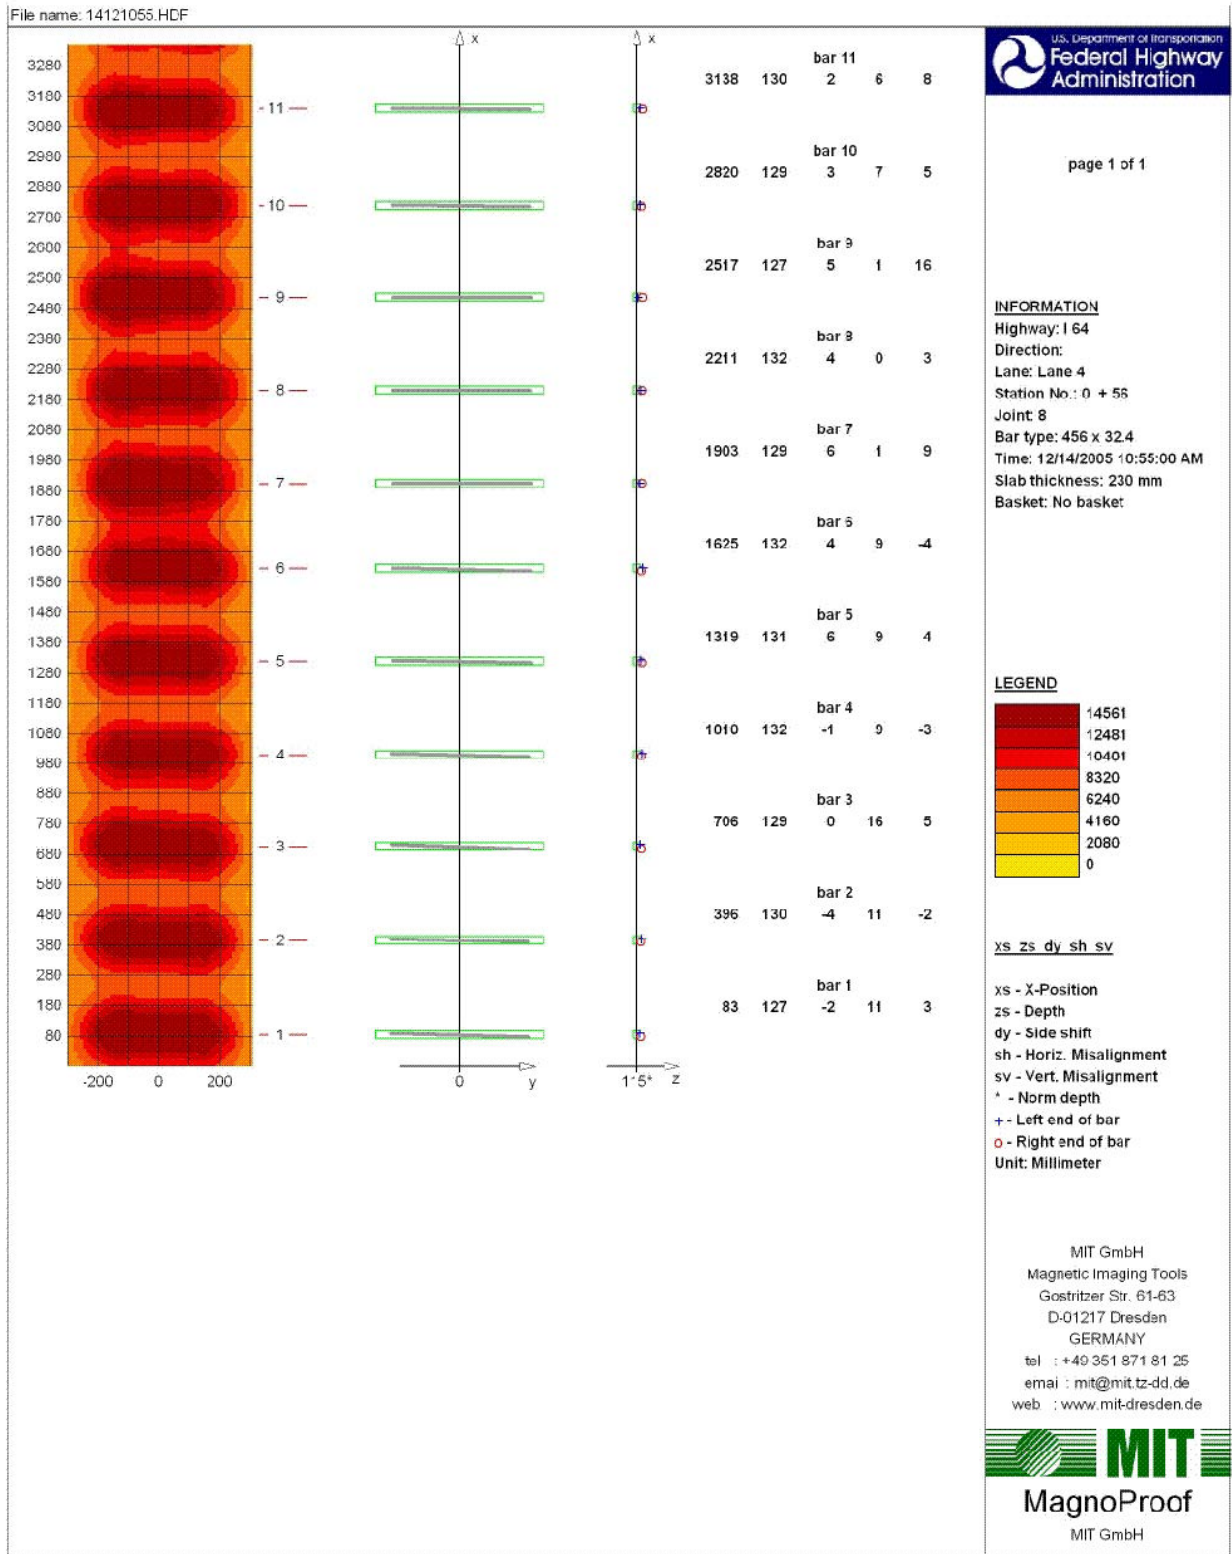
Figure 5. Typical Graphical Output from Laboratory Analysis of Joint 8 on I-64

The measurements from the field demonstrations were later analyzed using MagnoProof with a corrected bar type as the information became available. Figure 5 is the graphical output from the demonstration on I-64 for Joint 8, the same joint as for the field output in Figure 4. The original output is in color, which makes it easier to visualize the locations of the bars. The contour map on the left shows the signal intensity for each dowel bar, and it obviously identifies the presence of a bar by the high intensity of signal. The second column shows the actual position of the dowel, the thick gray line, in plan view with respect to the expected position as marked by a box.

The third column shows the elevation of the two ends of the bar with respect to the mid-depth of the slab. The text description of these measurements is included on the same output. For example, the following are the measurements for Bar 4:

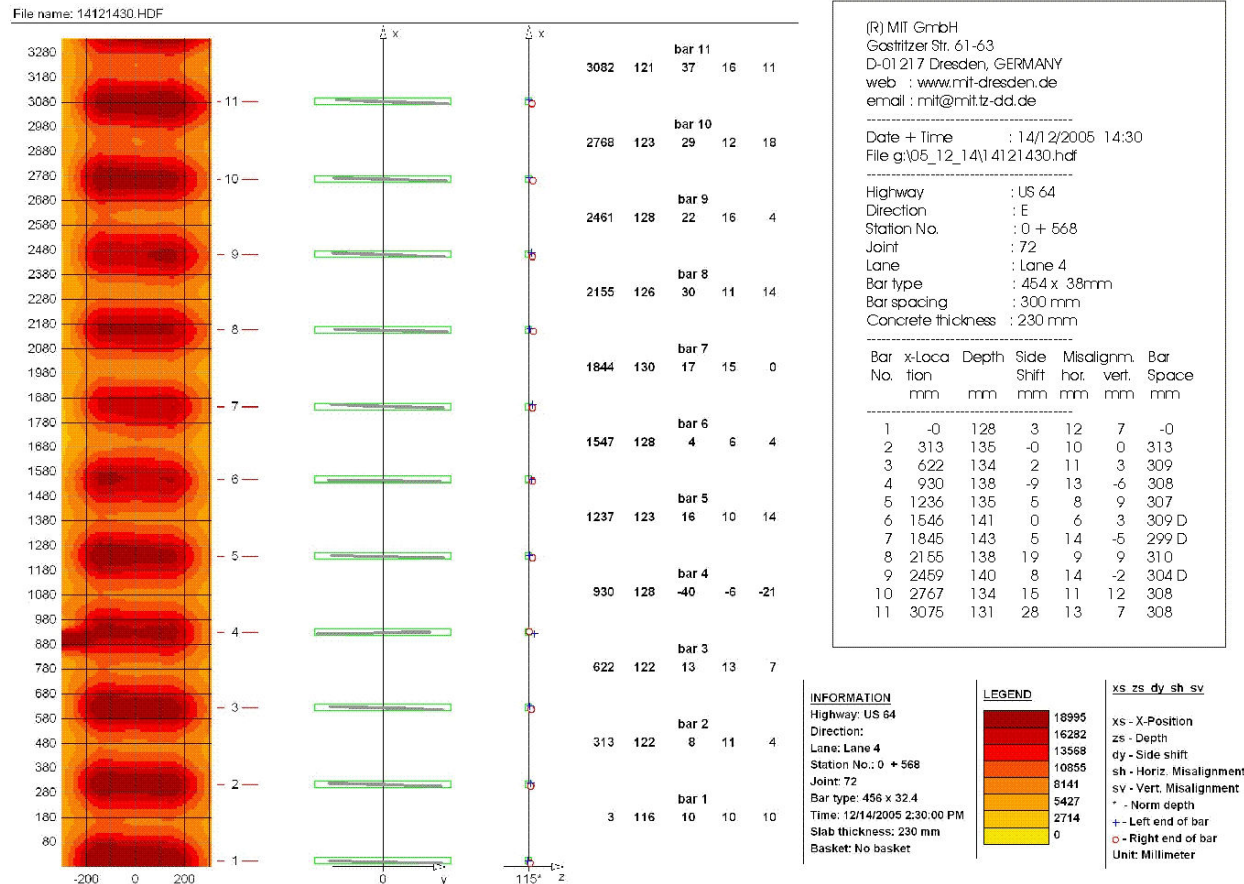
Figure 6. Comparison of Field and Laboratory Data Analysis (Joint 72 on I-64)

The dowels on I-64, as mentioned earlier, were placed on wire baskets. From the well-defined contour map, it seemed that shipping wires for the dowel baskets were cut before paving for all joints. During the field measurement, the wrong-size dowel bar (38 mm, 1.50 in) was used as an input on the MIT Scan-2, but it was later corrected (32 mm, 1.25 in) for laboratory analysis. This correction resulted in a significantly shallower (about 10 mm) depth for all bars, as shown in Figure 6. Another interesting observation in Figure 6 is the influence of a foreign metal on Bar 4. Although the signal contour map is clearly showing the presence of a foreign metal near Bar 4, there is no evidence in the field results (output). A total of 82 joints were scanned on I-64, and only 2 joints (Joints 58 and 80) did not produce meaningful results: 97.6 percent of joints provided useful information. Although Joint 58 gave a printout (text file) in the field showing the presence of only a few bars, further analysis with MagnoProof was inconclusive. A device error was suspected for both of these cases.

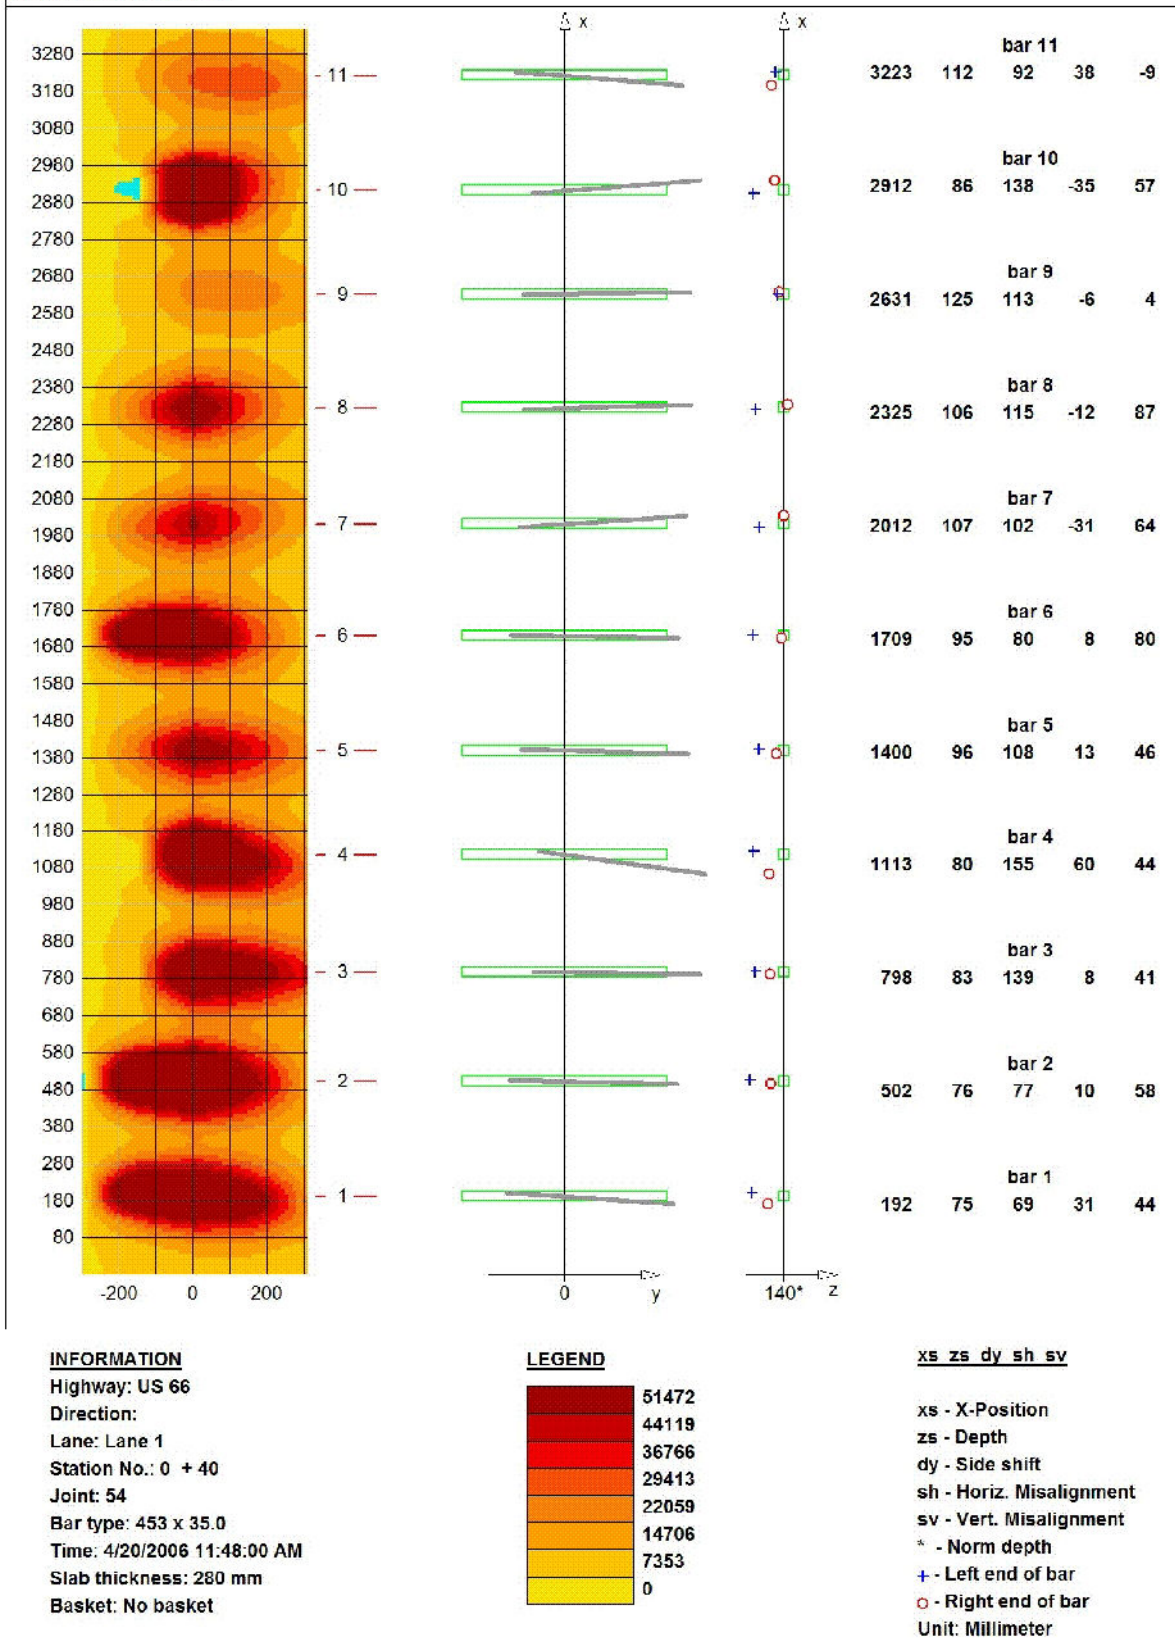
Figure 7. Results from Joint 54 on I-66

Joint 54 on I-66 had an exposed dowel bar near the left wheel path of the travel (outermost) lane. During the scan, MagnoNorm was unable to complete the analysis and no field results were obtained. Therefore, MagnoProof was used to analyze the data, and the bar locations were found as shown in Figure 7. There were 11 bars, and all of them show excessive misalignment. The exposed dowel is identified as Bar 10 with the “splotch” between 2880 and 2960 (blue in color) on the exposed side. The depths for all bars were shallow and vary from 75 to 125 mm (3.0 to 4.9 in). The side shifts were also excessive, with a range of 69 to 155 mm (2.7 to 6.1 in). Again, both the vertical and horizontal misalignments were excessive, with a value as high as 87 mm (3.4 in). So there were obvious reasons for the device not being able to accomplish data analysis in the field. Although MagnoProof, with the higher computing power, was able to provide a qualitative picture of the dowel bar locations, the results might still be

unreliable. It is important to note that dowels were mechanically inserted for this section of highway. Field verification was planned for this location and is discussed later in the report.

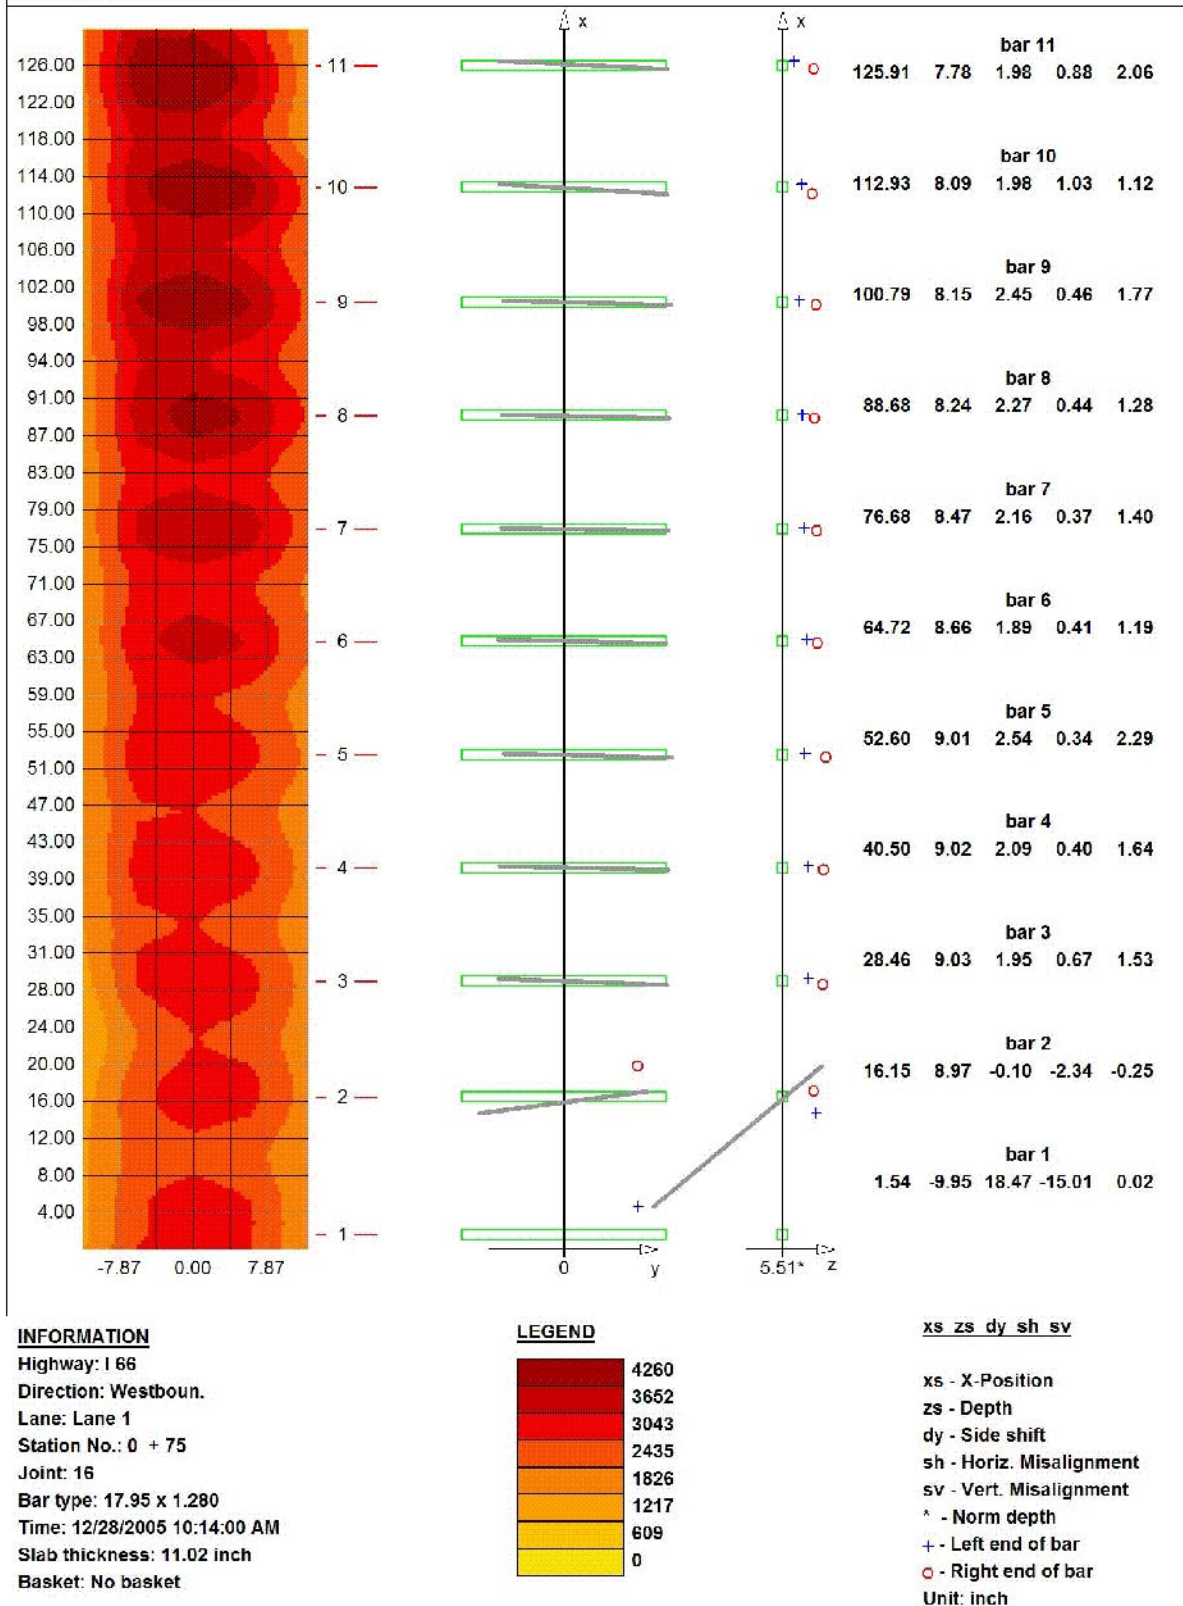
Figure 9. Laboratory Data Analysis Results for Joint 16 on I-66

Another joint (Joint 16) on I-66 had dowel bars too deep into the concrete. An example of the field output, shown in Figure 8, was obtained for this joint, and all 11 bars in the outmost travel lane were found to be deeper than 200 mm (8 in). These bars were also mechanically inserted using the DBI. Further analysis with MagnoProof revealed similar depths but showed a significant instability of the results leading to a completely different output with each successive run of the program. For many occurrences, it was not even possible to complete the analysis because of floating point over flow error; in one run, it showed only a few bars. Results are presented in Figure 9 from one successful run. Again, all bars except one are deeper than 200 mm (8 in). The data from this joint were unreliable and did not allow analysis because of the depth of the bars.

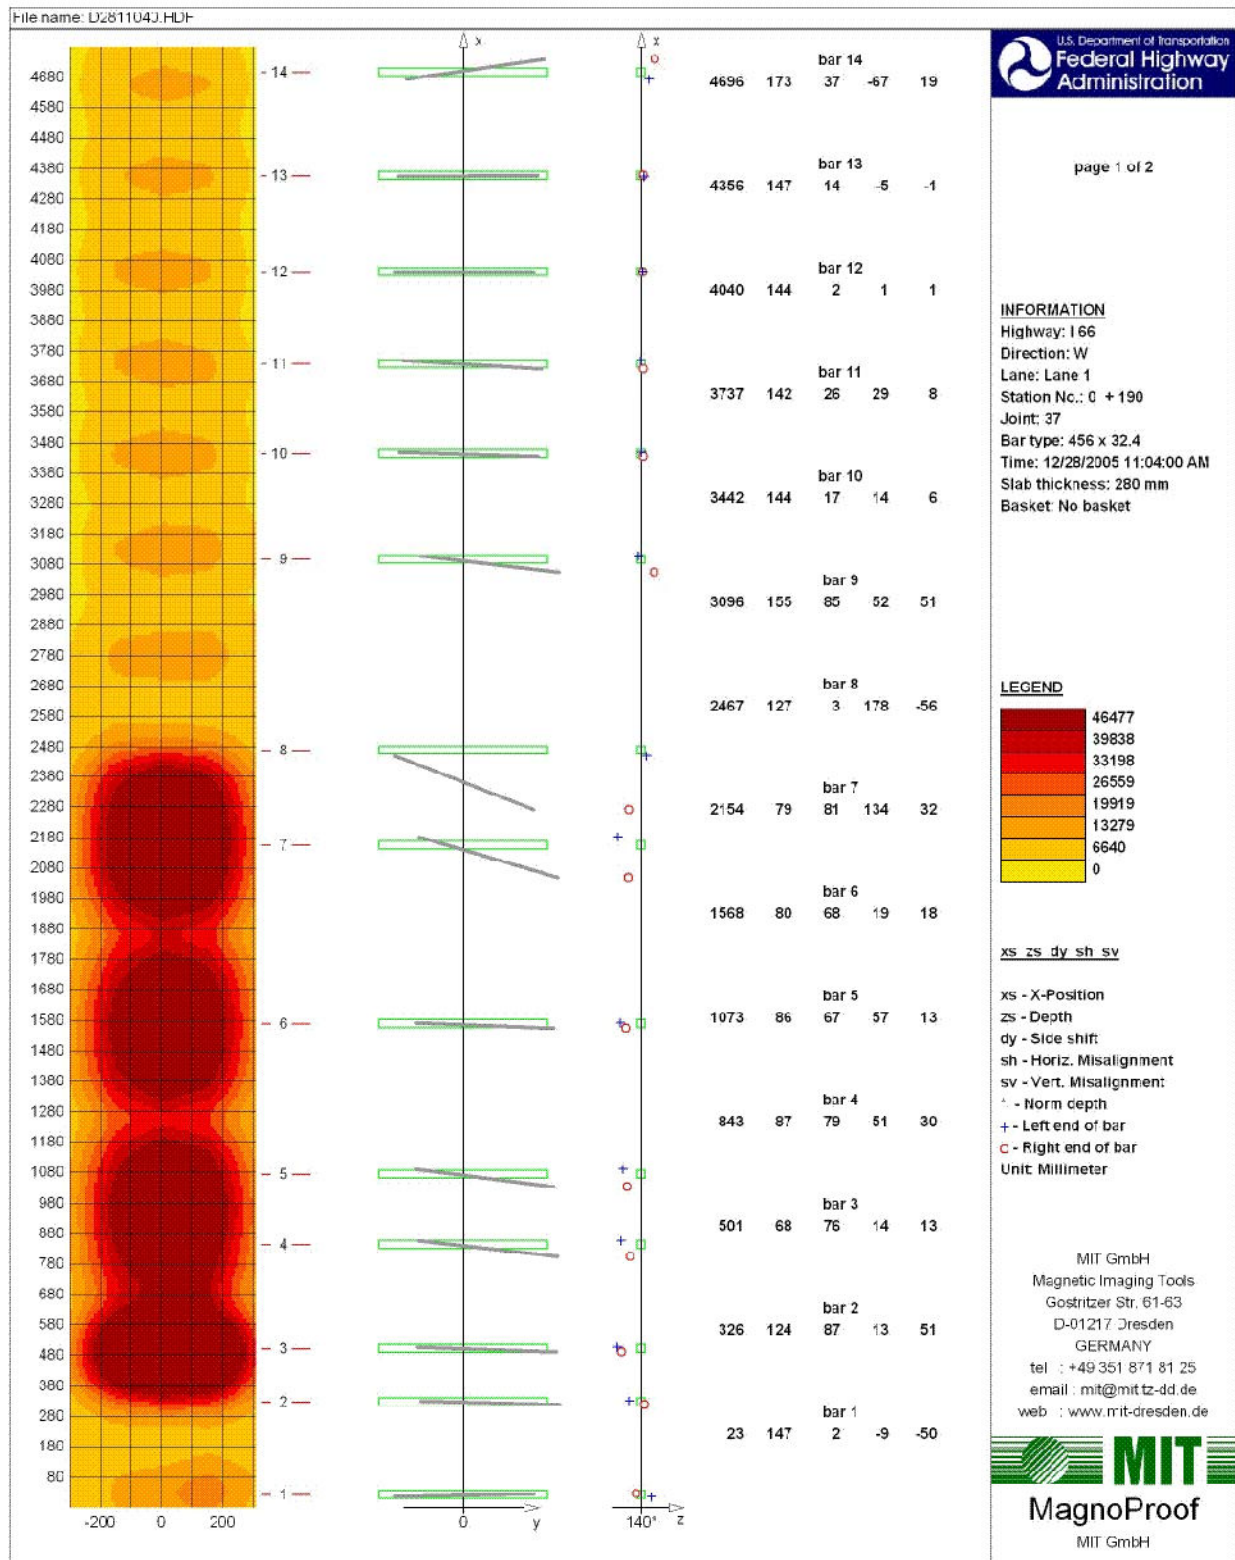
Figure 10. Signal Looping for Joint 37 on I-66

1. There was a strong magnetic signal loop surrounding several bars in the shoulder where dowels were on a basket. One such loop is shown in Figure 10 for Joint 37. Either the shipping wire was not cut or the epoxy insulation on the dowel itself might have been broken/abraded. When bars are too shallow and closely spaced, similar loops may be shown.
2. The dowel bars near the left wheel path of the outer travel lane are too deep and have excessive side shift. Although it was possible to scan most joints successfully, this trend was evident for many joints.
3. The end bars were only partially scanned.
4. Foreign metal was present in one or two cases.
5. For one joint, one dowel bar was exposed and several others were severely misaligned along with being at a low depth (<100 mm, < 4 in).
6. For one joint, (Joint 16), all the bars were deeper than 200 mm (8 in).

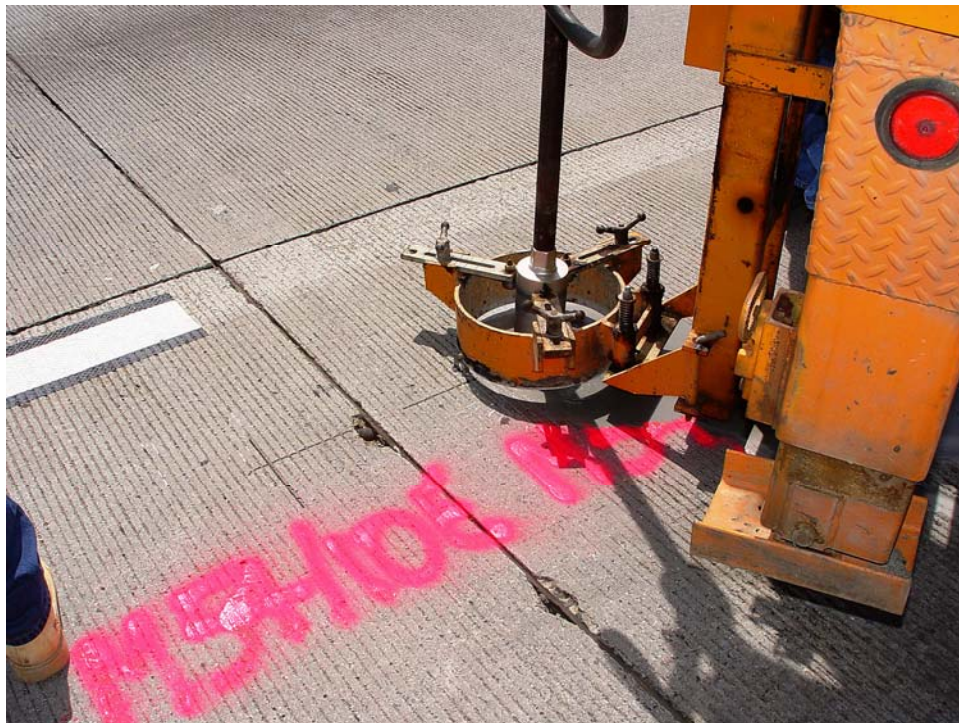
Figure 12. Field Coring Operation Near Joint 54 on I-66

No deviation was more than 40 mm (1.6 in), except the vertical misalignment for Bar 10 of Joint 54 on I-66. This bar has an exposed (visible) end at the joint, excessive side shift, and excessive vertical misalignment, which are all good reasons for unreliable results. An exposed dowel bar should be alarming to the engineer without the need for a scanning device.

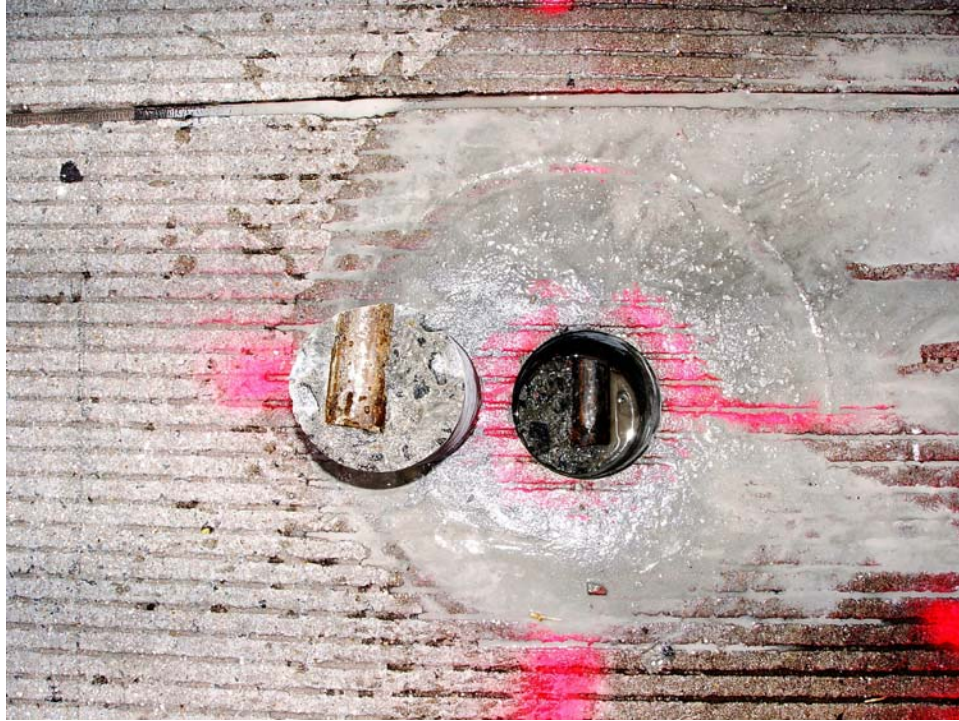
Figure 13. Field Core and Dowel Bar Near Joint 43 on I-66

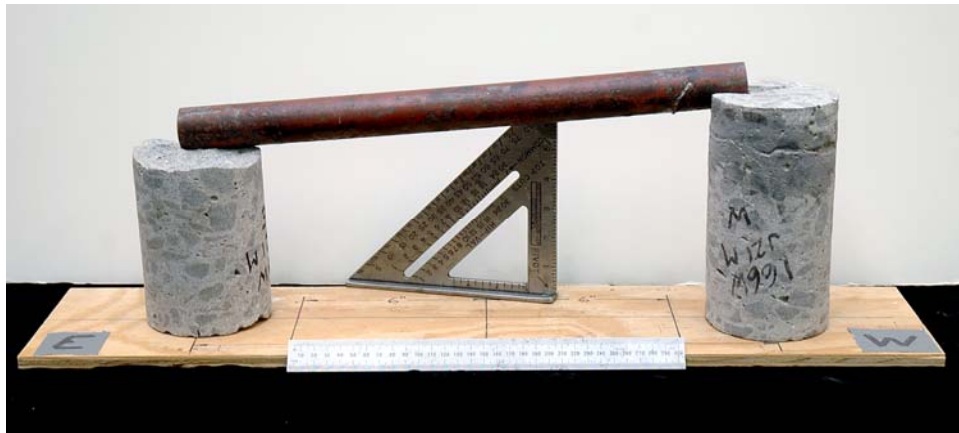
Of these nine bars, only one bar did not have any signal interference: Bar 9 of Joint 21 on the I-66 travel lane (Table 4). The location of this bar was about 12.5 mm (0.5 in) off the actual location. The distance measurements in the field might have contributed to this error. All other parameters were within 10 mm (0.4 in), with a range of 1.0 to 9.5 mm (0.04 to 0.37 in).

Figure 14. Laboratory Recreation of Dowel Bar Orientation for Dowel 9 of Joint 21 on I-66
