# GEOTECHNICAL STUDIES FOR THE ADELAIDE RAIL REVITALISATION PROJECT: A CASE STUDY COMPARING IN-SITU AND LABORATORY TESTING OF BALLAST AND SUBGRADE MATERIALS

## SUMMARY

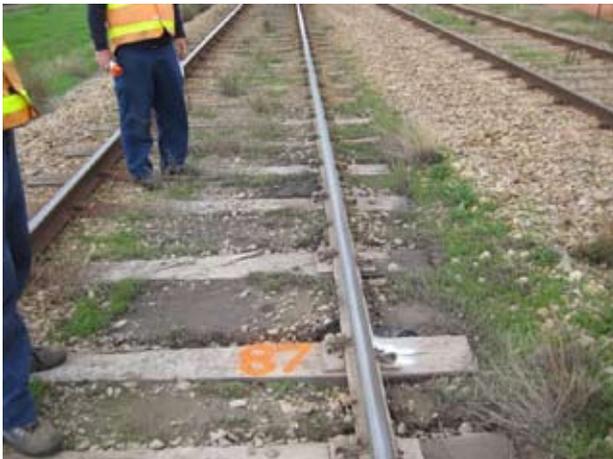
During the walkover a number of areas of pumping and fouling of the track were identified. The areas of pumping tended to be where evidence of greater than 50 mm of vertical movement had been occurring over 4 or so sleepers. Movement was identified by gaps between sleepers and ballast, mud on the rails and sleepers, and materials pushed up by sleeper movement. In extreme cases water was visible in the gap between the sleeper and the ballast.

From review of the underground service plans and observations made during the walkover, some of the pumping areas coincided with underground assets. Areas identified as fouled ballast during the walkover contained excessive fines visible in the ballast matrix (Figure 1).

**Figure 1: Walkover inspection with track pumping**

The location of a 'perched' water table (Figure 6) within the ballast formation severely weakens clay rich subgrade materials, further facilitating the settling (or punching in) of the ballast formation into the subgrade. Track formation settlement also causes additional fines to migrate into the ballast and sub-ballast material. This process results in track pumping (Figure 1).

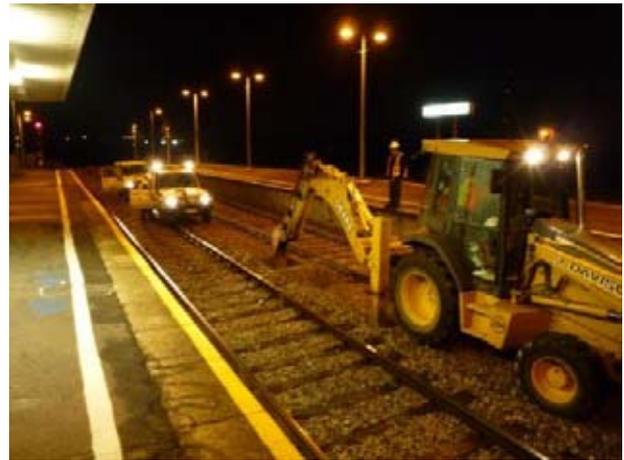
The test pits were excavated by a backhoe using a 300 mm wide bucket and were located parallel to the rails at the end of the sleepers (Figure 2). Test pit and lithology depths were recorded from the top of the adjacent sleepers. Test pits were first excavated through the ballast to the top of the natural material.

**Figure 2: Test pit excavations**

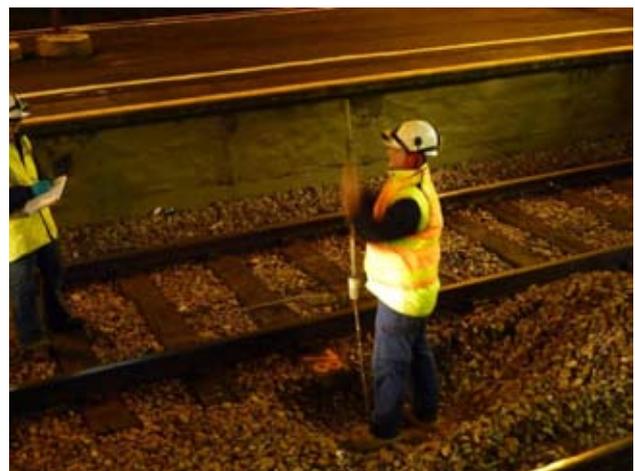
A Dynamic Cone Penetration (DCP) test was then undertaken to a depth of at least 900 mm or refusal, recording the number of blows per 100 mm of penetration (Figure 3). DCP results provide a direct correlation to in-situ subgrade strength such as the California Bearing Ratio (CBR)<sup>[1]</sup>.

**Figure 3: DCP testing into subgrade**

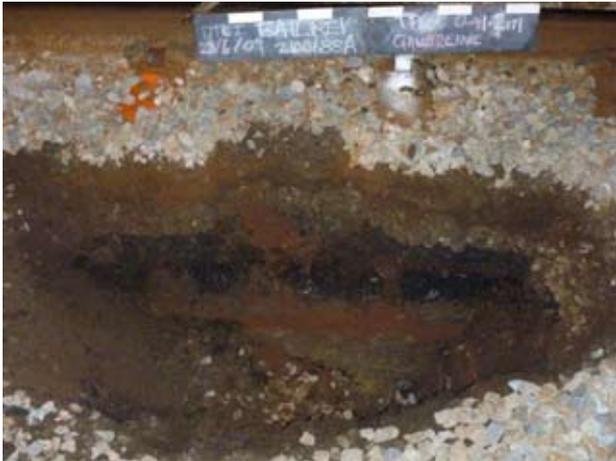
Where a clearly defined upper clean ballast layer was encountered the layer was separately sampled. In almost all cases the ballast was fouled (except for the surface layer of material) and was generally comprised of one or more layers of ballast (and sub-ballast) material excavated from above the natural material (see Figure 4 for an example).

**Figure 4: Layers of ballast, sub-ballast, cinders, fill and subgrade**

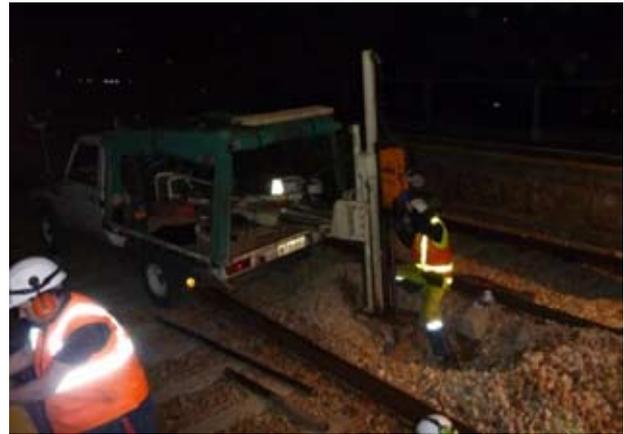
drilled using the dynamic push tube technique with a 4WD utility mounted drill rig (Figure 5).

**Figure 5: Drilling into rail formation**

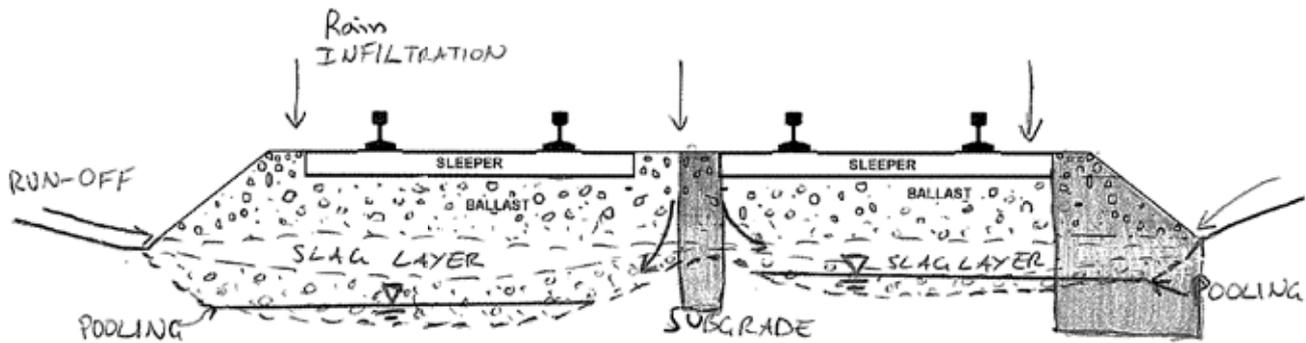
The investigation program encountered many ballast and subgrade configurations along the railway line. Generally the ballast was clean on the surface only and fouled ballast was underlain by sub-ballast layers of slag and coal cinders, and even buried ballast and sub-ballast layers. The depth of the ballast and sub-ballast materials generally exceeded the height of the rail embankment, which indicated that the track formation was forming a "bath" configuration similar to that sketched in Figure 6.

**Figure 6: Typical track formation configuration**

This rail track configuration increases infiltration of rainwater, not only from the poorly drained sides of the embankment but also through the ballast material, into the sub-ballast and subgrade materials.

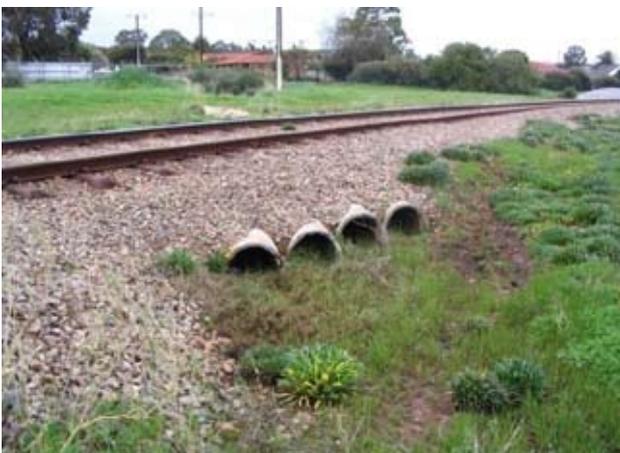
The investigation program identified a number of drainage issues along the track. Drainage systems were generally not well constructed causing blockage in low points due to the lack of suitable outlets. Other areas were found to be poorly maintained and contained build up of silt and fine materials with no mechanism to divert water from the track formation. Culverts were also blocked, damaged or eroded due to lack of head and wing walls (see Figure 7).

**Figure 7: Poor drainage and blocked culvert**

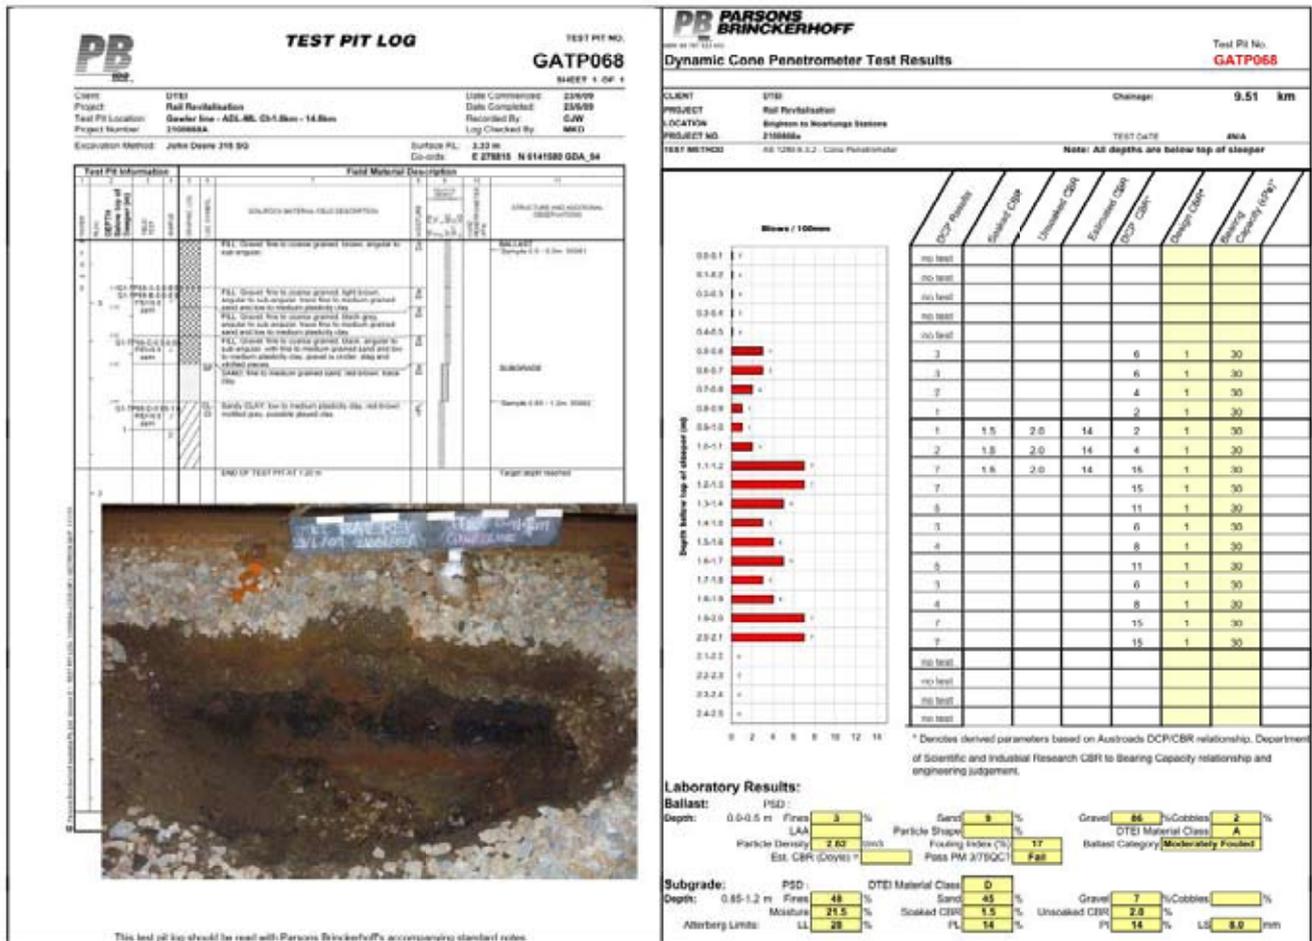
An example of this A3 sheet is presented in Figure 8. The new A3 reporting sheet replaced five pages of information which reduced the size of each report by several hundred pages and facilitated the effective transfer of design information.

Figure 8: A3 datasheet

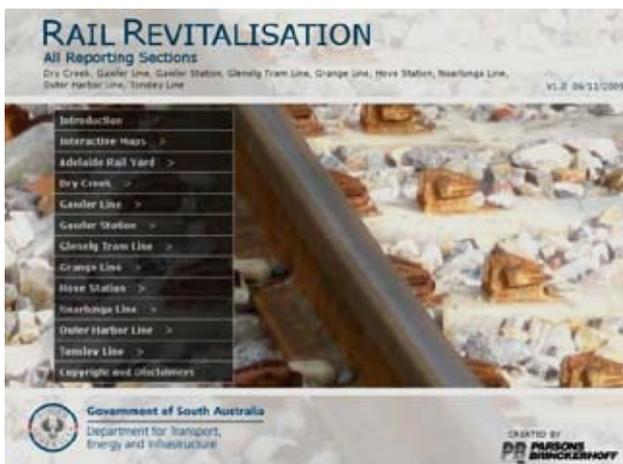
Figure 9: GIS database

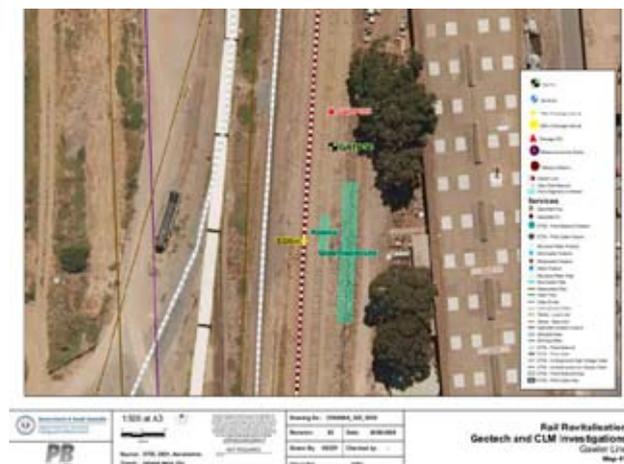
The information on the DVD included walkover observations, underground services locations, geotechnical and environmental site investigation data, laboratory results and reports. It also included geological, topographic, cadastral and soil maps and links to photographs taken during the project (see Figure 10).

Figure 10: GIS plans

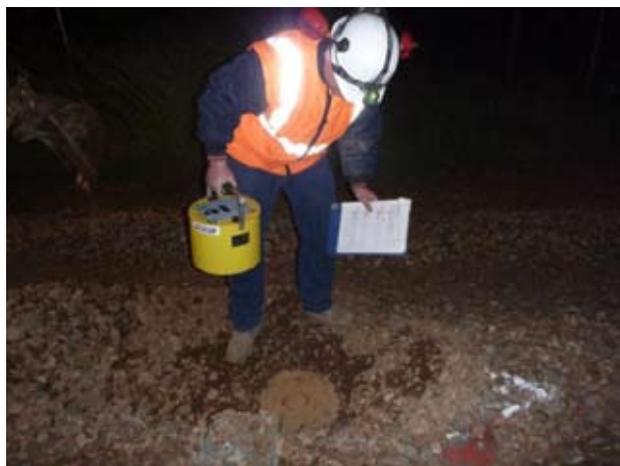
The Humboldt GeoGauge was found to be more susceptible to seating conditions within the coarse ballast which caused more variable results to occur at the same location. This required a thin bed of dry sand on the ballast material to provide reliable contact (Figure 11).

**Figure 11: Humboldt GeoGauge**

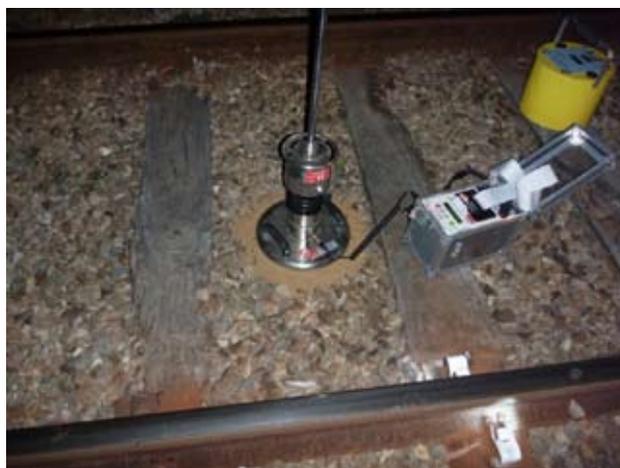
The LWFWD recorded more consistent results at each location, was less susceptible to ballast material variability due to its larger base plate (300 mm) and required no prior surface preparation (Figure 12). The first three seating blows prior to the three recorded blows provided sufficient surface preparation.

**Figure 12: Zorn ZFG2000 LWFWD**

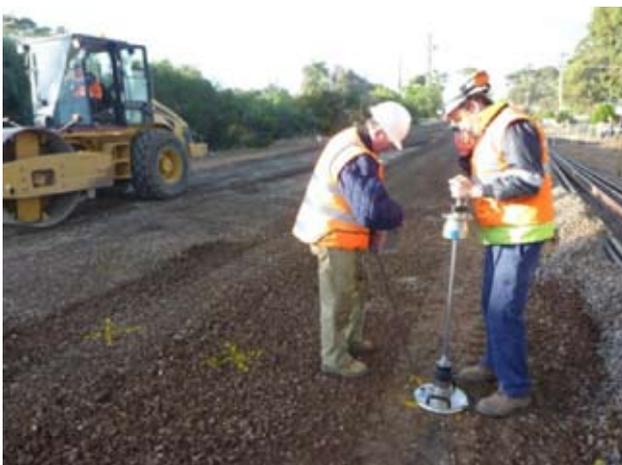
A set of three tests were conducted at each sub-location. At the final grade level, two series of three tests were also conducted, the first three tests prior to compaction and the second series of three tests after compaction and prior to placement of clean ballast (Figure 13).

**Figure 13: LWFWD testing during track works**
