# Evaluation of Dowel Bar Inserter Practices in PCC Pavements with Magnetic Tomography Technology

Report MPMC-04

Final Report  
26-1121-4027-001

December 2016

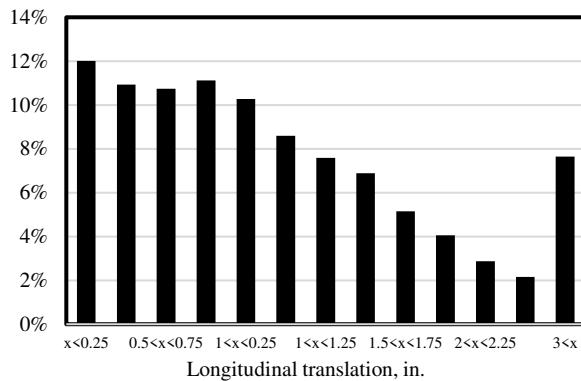
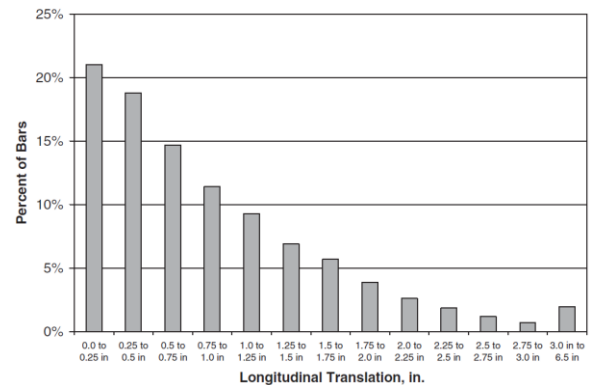
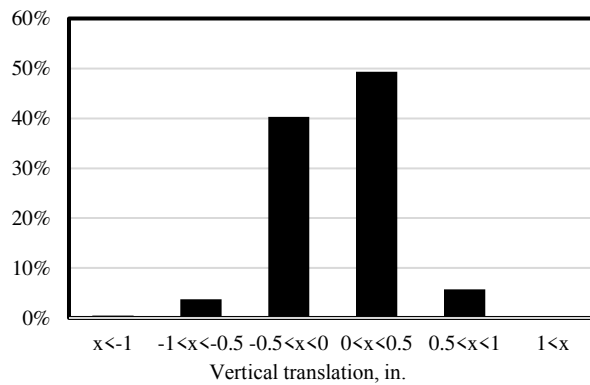
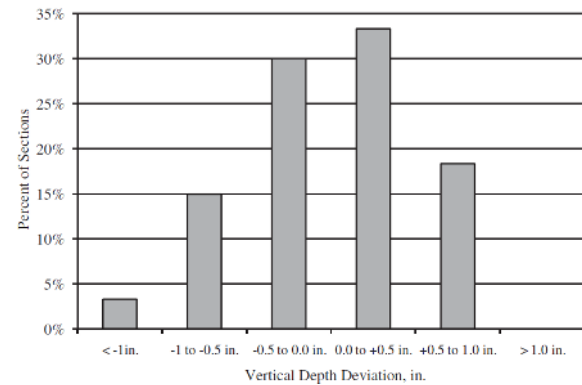
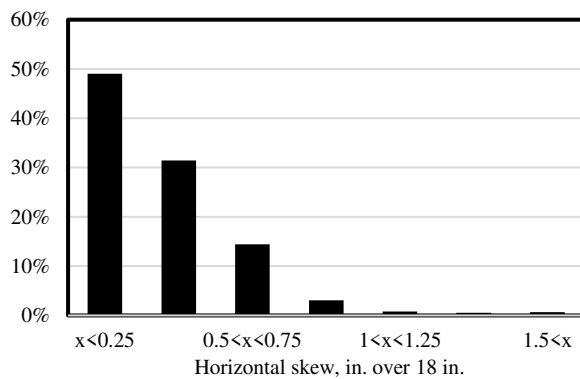
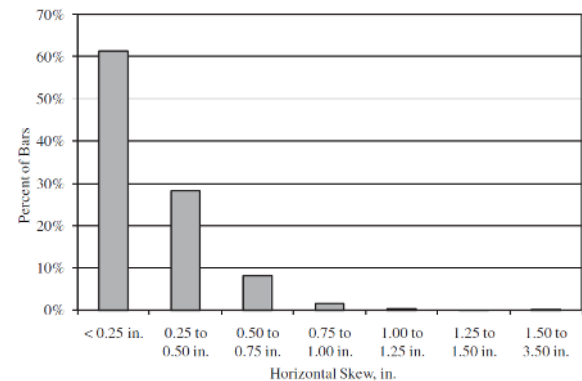
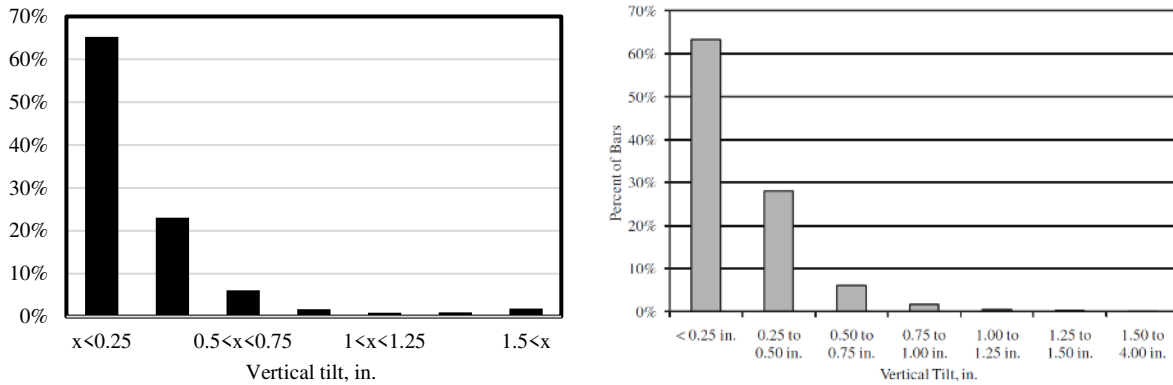
**Figure 3.5** Comparison of MIT Scan-2 data with results of NCHRP study

To compare the performance of the DBI used in these 4 projects with typical DBI and dowel basket practices, misalignment graphs of all projects have been juxtaposed with data from the study by Khazanovich et al. (2009) for over 2,300 joints. Figure 3.5 shows that longitudinal translation values of the dowels placed by the DBI are higher than the average reported by the NCHRP study. This could have happened due to inaccurate marking of the joints for saw-cut operations, as well as using a defective DBI. The vertical translation of the dowels, however, was

better than NCHRP values, which could mean that the concrete mix used with the DBI was stable enough to hold the dowels in place after insertion. Horizontal skew and vertical tilt values for the scanned joints are comparable with average values reported by Khazanovich et al. (2009).
