research report

Field Demonstration of Magnetic Tomography Technology for Determination of Dowel Bar Position in Concrete Pavement

1. Report No. FHWA/VTRC 06-R40	2. Government Accession No.	3. Recipient's Catalog No.	
4. Title and Subtitle Field Demonstration of Magnetic Tomography Technology for Determination of Dowel Bar Position in Concrete Pavement		5. Report Date June 2006

June 2006
VTRC 06-R40

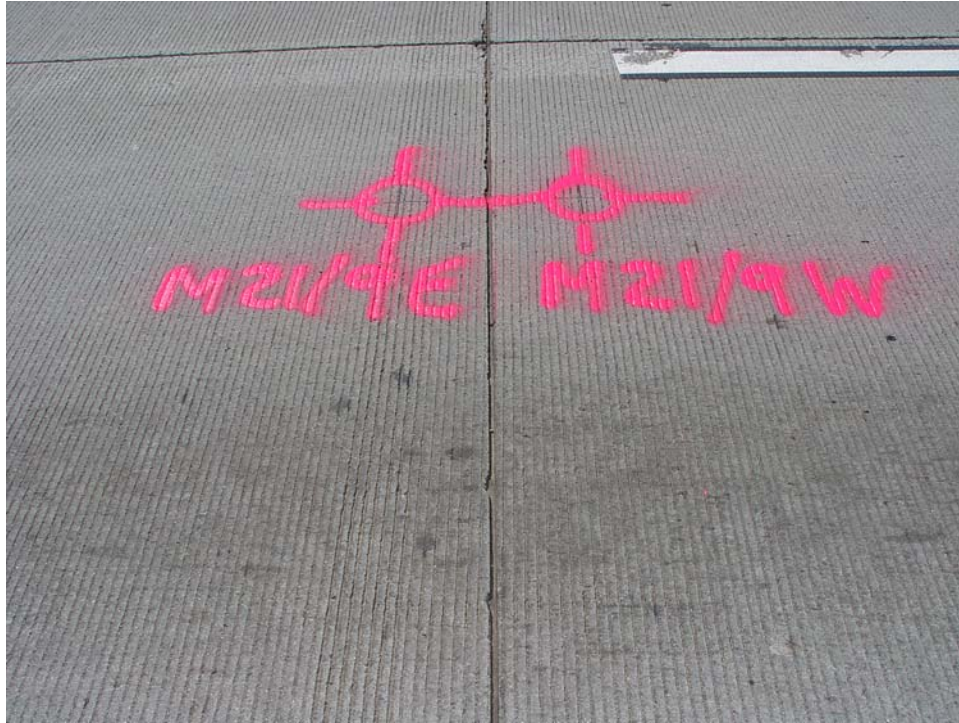
Figure 11. Field Marking of Dowel Bar Near Joint 21 on I-66

It was planned to core the two ends of dowel bar to physically locate its position. Although we had scanned results from earlier tests, a fresh scan was performed right before coring to confirm the location of target bar. The dowel bar location was marked on the pavement based on this scan results before actual coring as shown in Figure 11 for Joint 21 on I-66. The coring operation on I-66 near Joint 54 on the travel lane is shown in Figure 12. The concrete pavement was cored about half an in into the dowel bar in order to confirm the location and facilitate the subsequent measurements. The pulled out core and dowel bar inside the bore hole is shown in Figure 13 for Joint 43 on I-66. The measurements of depth and end locations were taken in the field to verify scanned results of bar location. Dowel bar orientations were recreated in the laboratory from such measurements and actual cores. The dowel bar orientation in Figure 14 was recreated in the laboratory for bar 9 of Joint 21 on I-66 travel lane. An actual dowel bar of the same size as in the field was used to recreate the bar orientation.

Project	Lane	Joint No.	Bar No. ^a	Remarks
I-66 Westbound	Travel (DBI)	21	9	Drilled through dowel bar
		43	7	
		54	10	One core because of exposed edge
	Shoulder (Basket)	21	7	
		42	3	
		54	2	
US 460 Eastbound	Travel (Basket)	18	10	
		37	6	
		72	2
